FIRST INTERNATIONAL
SYMPOSIUM ON
VOLCANIC ASH AND
AVIATION SAFETY

**IMPACT OF VOLCANIC ASH FROM REDOUBT
VOLCANO ERUPTION ON GE CF6-80C2
TURBOFAN ENGINES**

**Z.J. Przedpelski, General Electric Aircraft Engines,
Evendale, OH, and T.J. Casadevall, U.S. Geological Survey,
Denver, CO**

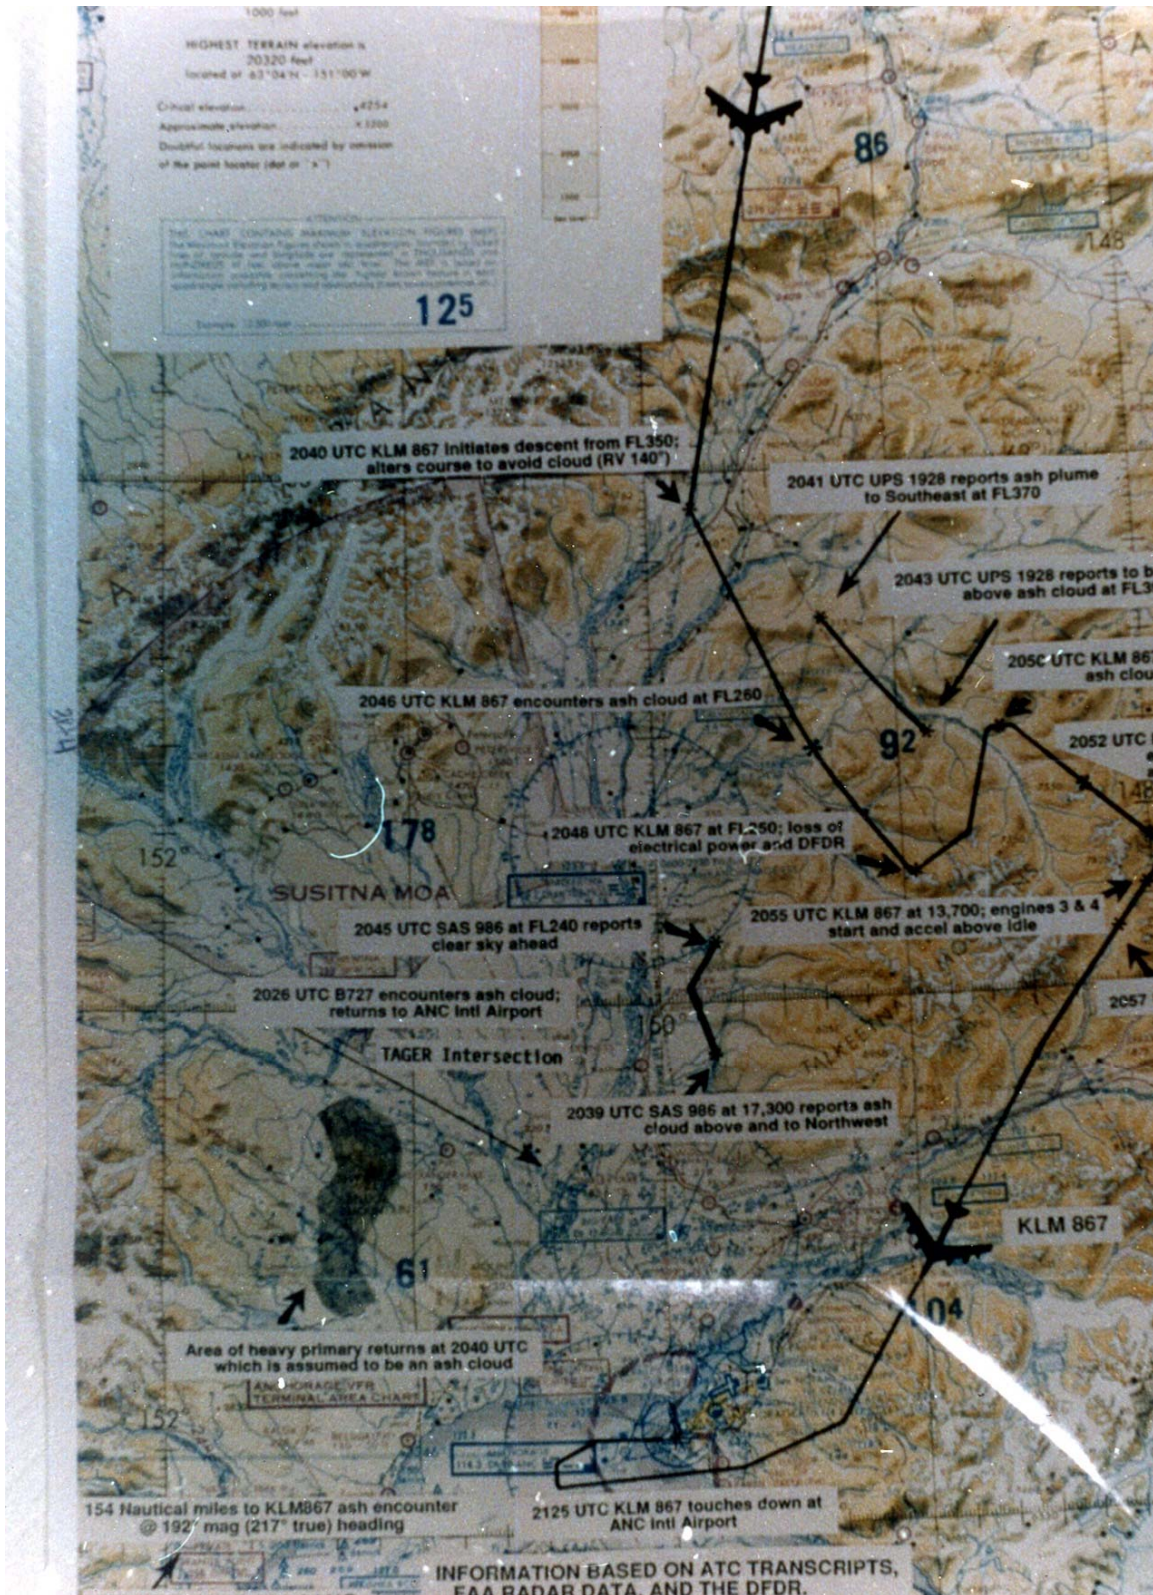
Figure 1 KLM Flight Path

The time sequence of events is shown on the annotated aircraft flight path in Figure 1.

At 1146 A.M. AST, while leveling off at an altitude of 25,000 feet, KLM867 entered a heavy volcanic cloud. Maximum power climb was selected and approximately one minute later all engines decelerated. Engines 1 and 3 decelerated to sub-idle core rotor speed (N2) while engines 2 and 4 settled down at ~80% N2 for approximately 20 seconds before decelerating to sub-idle N2. Aircraft and engine response during that period is shown in Figures 2 and 3.

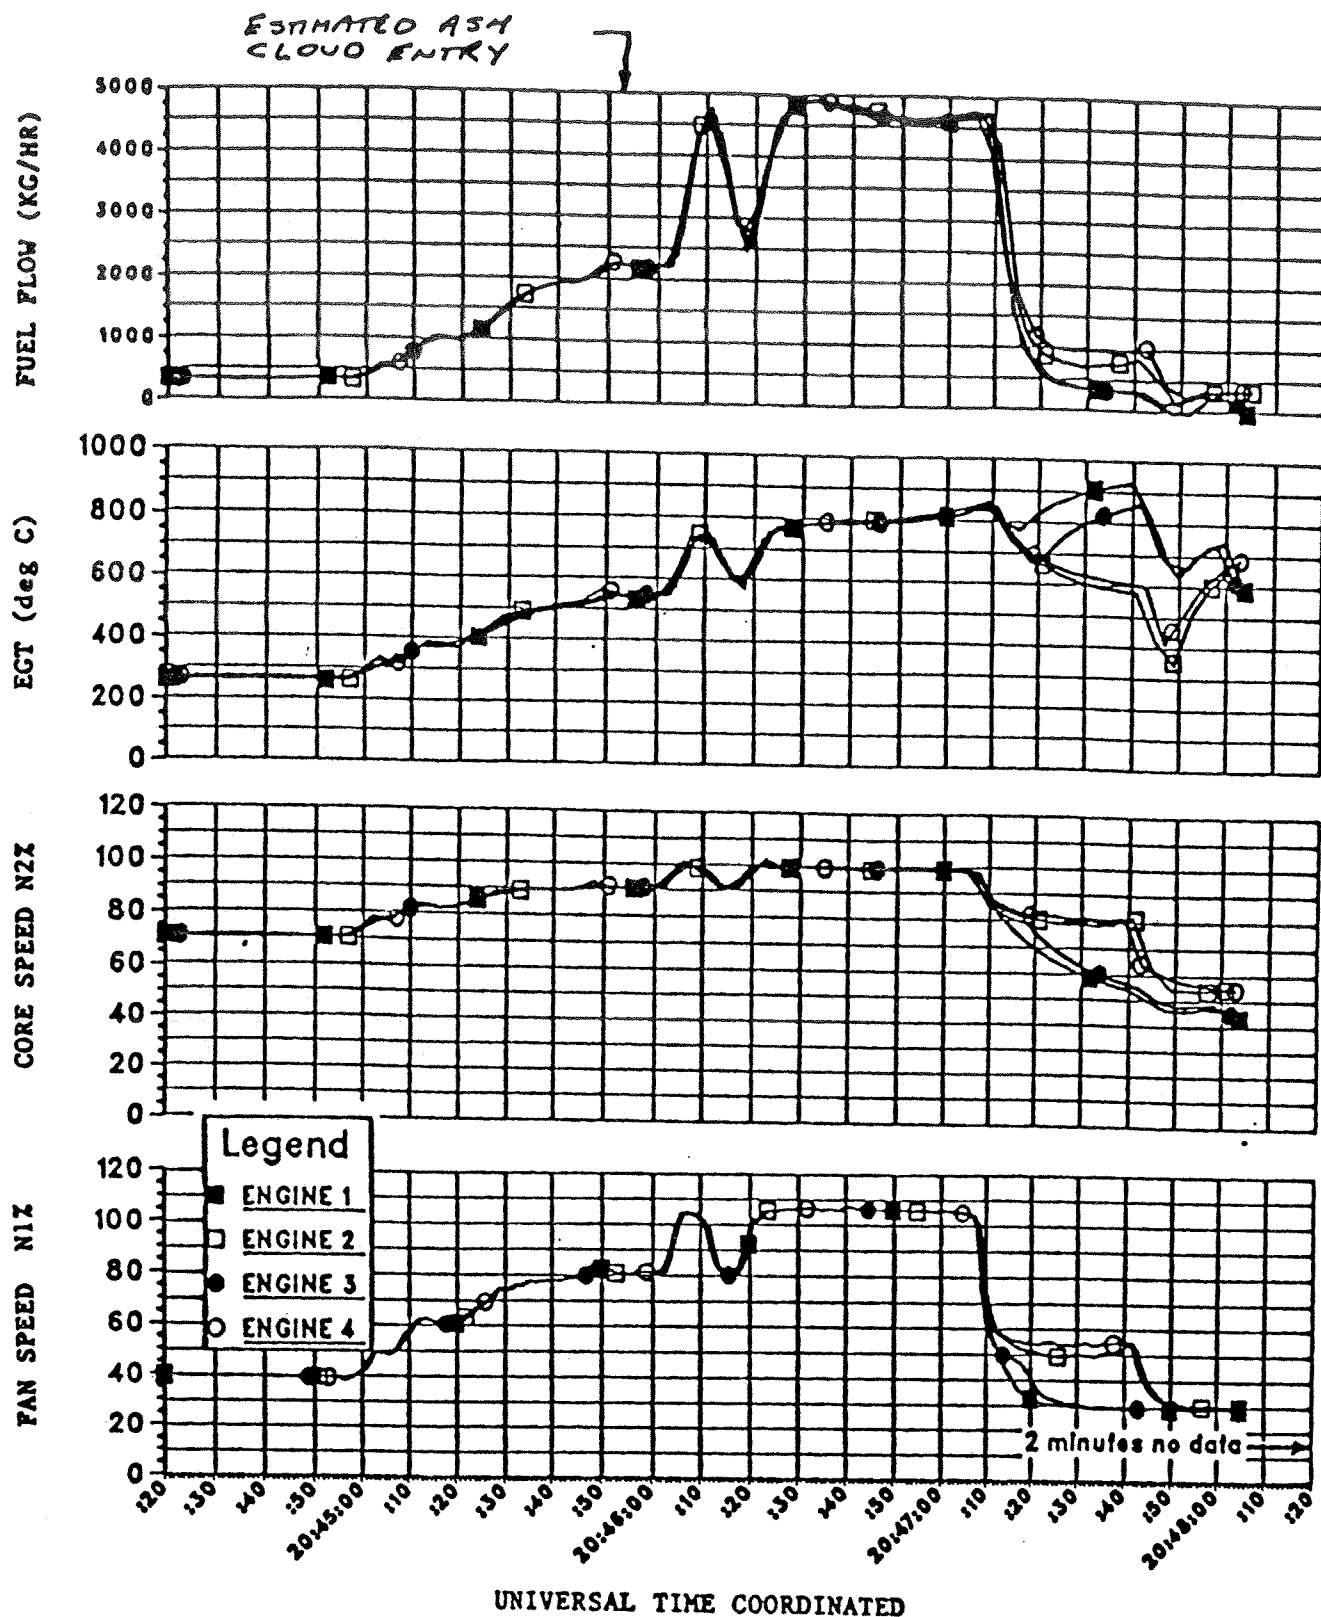
Figure 3:

Engine Parameters From Cloud Entry To
ENGINE SPOOL DOWN

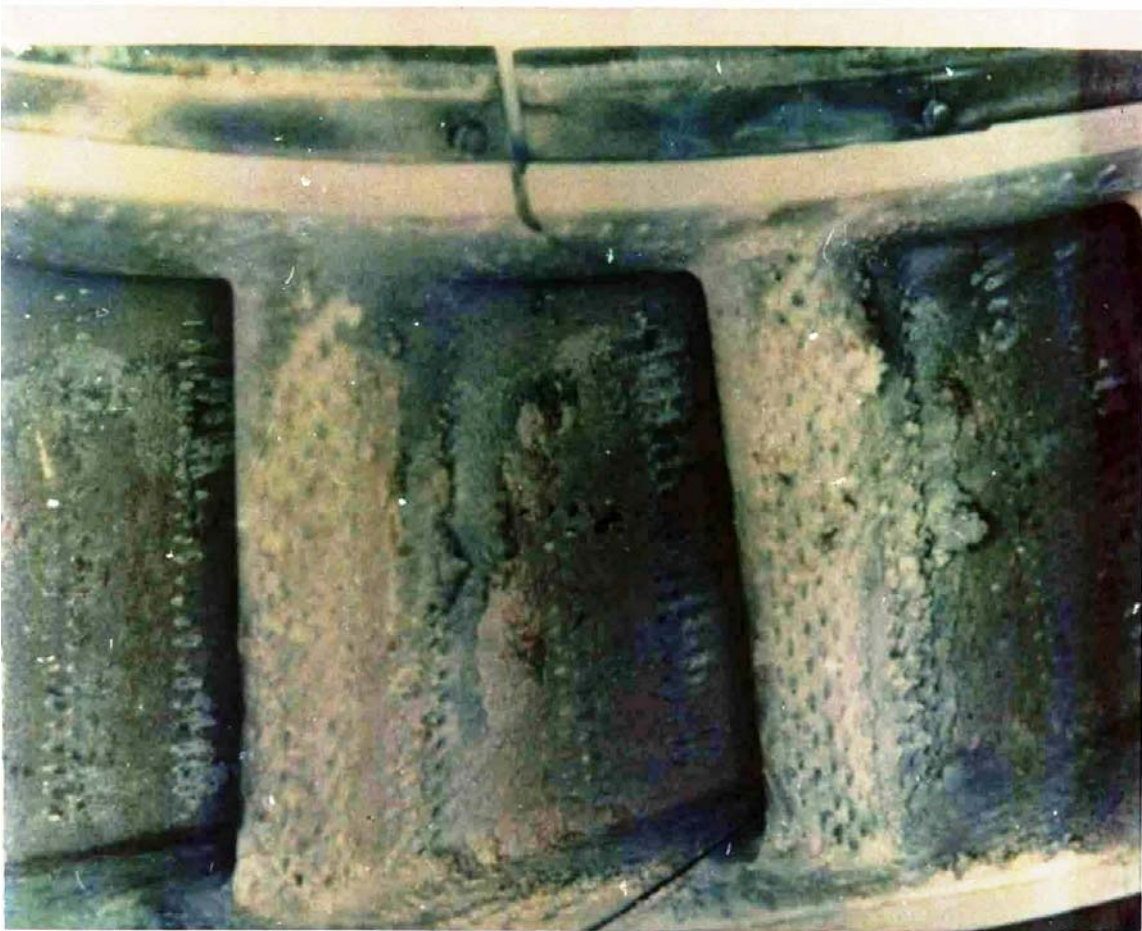
Figure 4

The Stage 1 nozzle effective flow area restriction was caused by resolidification and buildup of melted ash particles on the leading edges and on the pressure surfaces of the individual NGV's. This effective flow area restriction was estimated to be 8%. This buildup also resulted in an increase in pressure loss across the nozzle and a reduction in HPT efficiency. Total HPT efficiency loss, including the stage 1 HPT blade clearance increase was estimated to be 7%.

The ash contained some volcanic glass material with a melting point of ~1,200°C. This material is considered to be responsible for rapid build-up of deposits on the stage 1 NGV's; however, higher and lower melting point components of the ash were also present in the NGV deposits. The unmelted particles adhered to the semi-molten layer of the glassy material on the stage 1 NGV's. (Casadevall, Meeker & Przedpelski, this volume)

Stage 1 HPT Nozzle Guide Vane Leading Edge Deposit

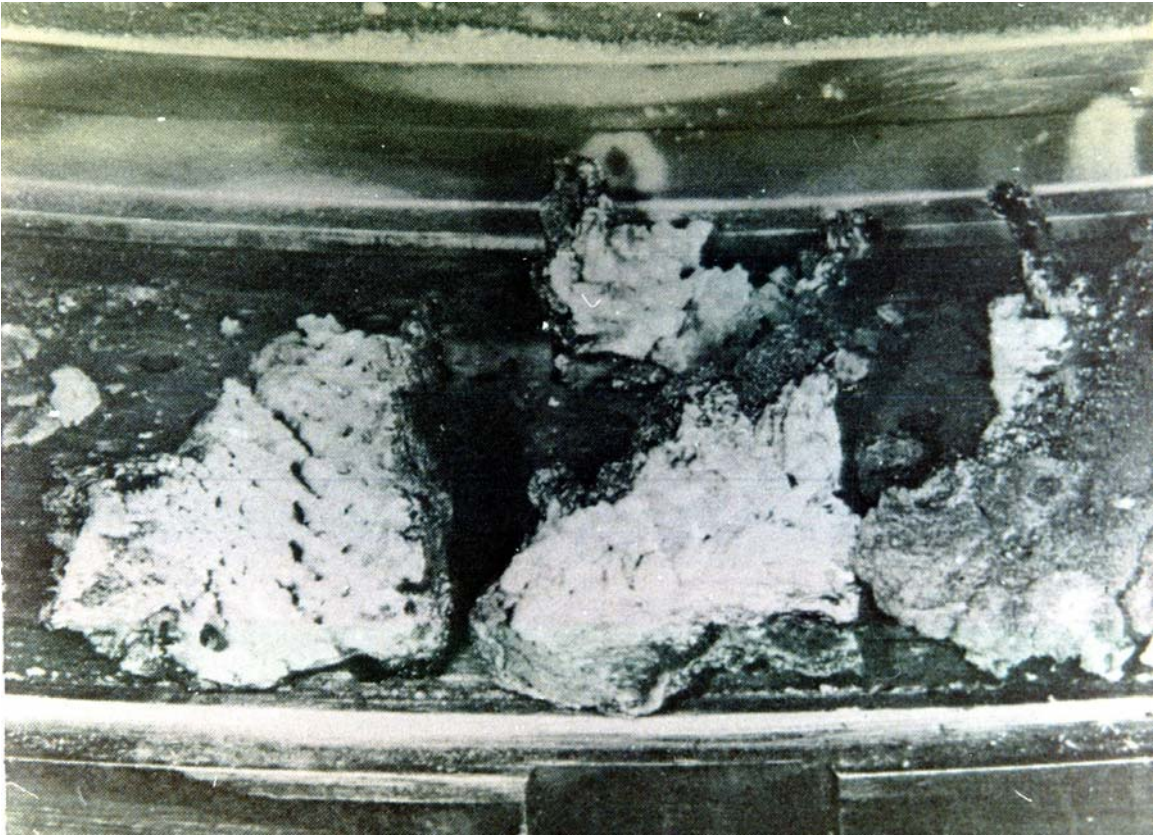
Figure 5

The lowering of the temperature following manual fuel supply cut-off increased the viscosity and brittleness of the built up material. The thermal and pressure/velocity transients associated with the fuel off/on/off cycle dislodged some of the nozzle deposits. The density of these deposits was low and consequently there was no downstream airfoil damage. Successful starts were achieved after a portion of these deposits were dislodged.

**Stage 1 Nozzle Guide Vane Leading Edge Deposits
Disclosed During Disassembly**

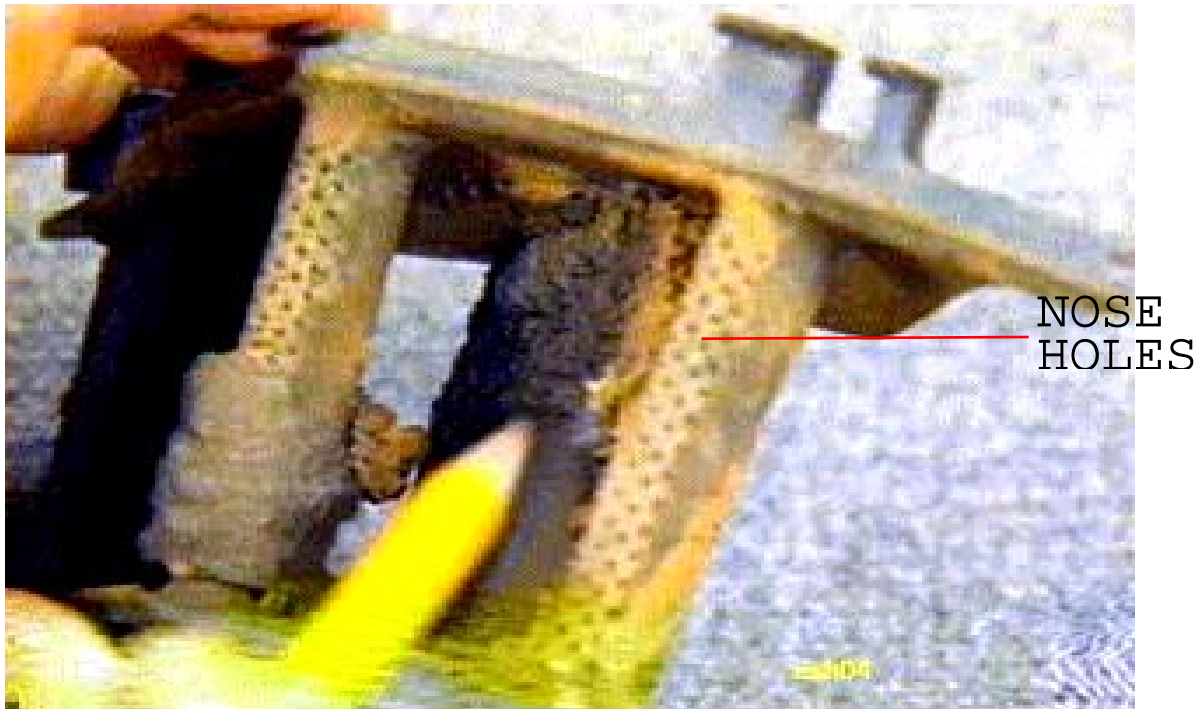
Figure 6

The engines' operation during the high power climb was consistent with rapid reduction of the stage 1 nozzle flow area and associated high pressure turbine (HPT) efficiency reduction. Approximately one half of the maximum deterioration was still present following the successful restarts. Visual inspection of the number 1 engine (ESN 702-131) revealed thick deposits of melted and resolidified ash material on some of the stage 1 NGV's (Figure 4). These deposits were brittle at room temperature and many pieces fell off during the engine transportation and disassembly (Figure 5). The remaining deposits could be easily removed by hand. It was inferred that these deposits built up to maximum just prior to engines' deceleration and gradually became dislodged during the start attempts and during the subsequent engine operation. Based on borescope inspections conducted at Anchorage, approximately 40% of the NGV's were still covered by thick deposits after landing (Figure 6).

**Sketch of the Stage 1 HPT Nozzle Based on Inspection of
Engine No. 1**

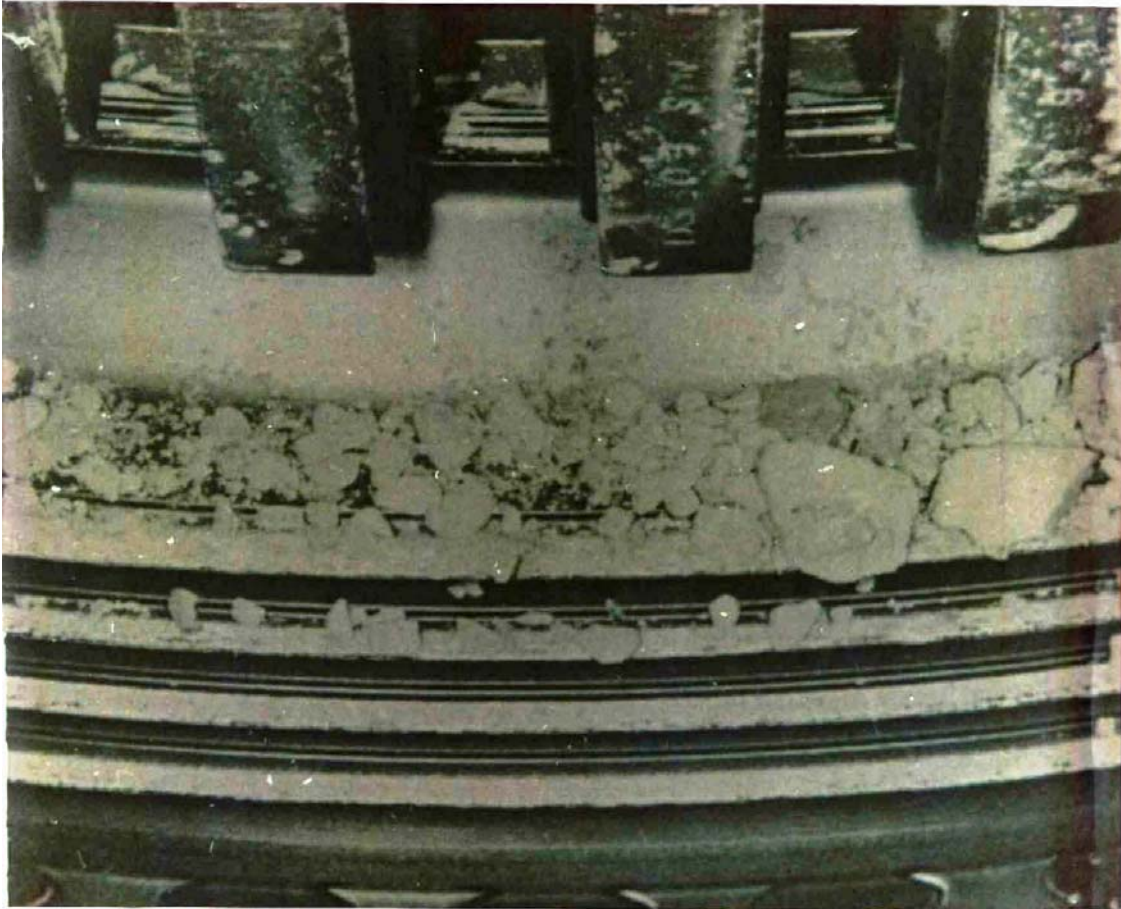
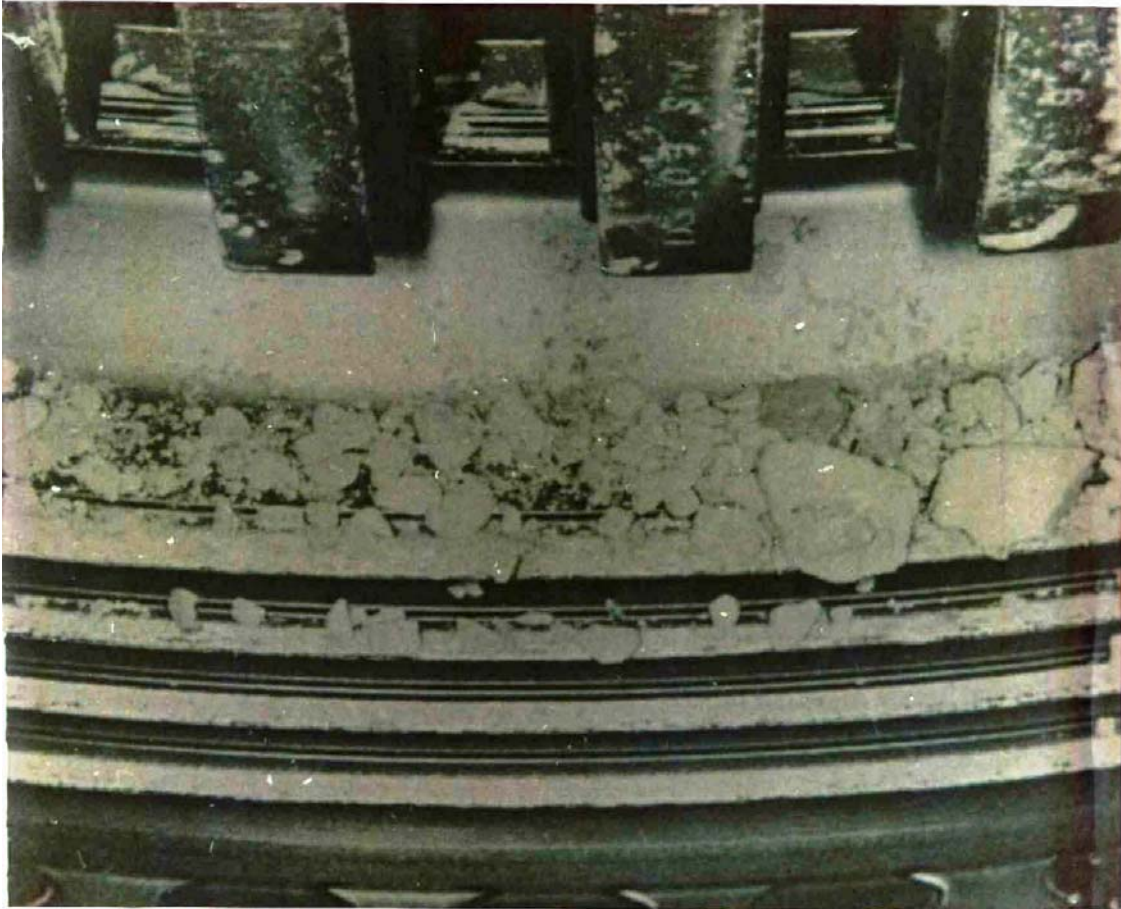
Engine No. 1 inspection indicated that there was no significant plugging of any of the HPT cooling circuits; however, there was a heavy fine powdery ash buildup within the HPT rotor cavities (Figure 7).

Figure 7
Accumulation of Ash in the HPT Rotor

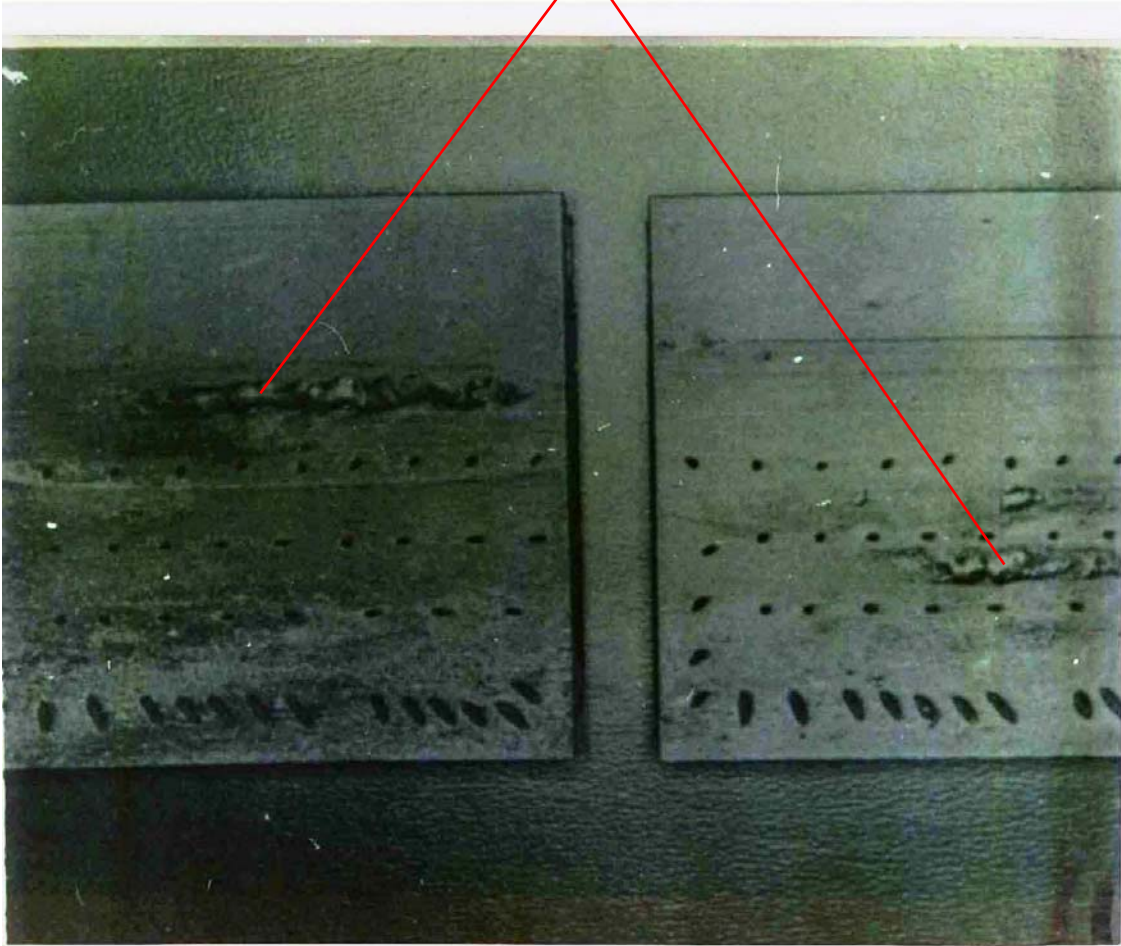
The Stage 1 HPT bucket clearance increase was caused by local hard buildup of melted/resolidified ash material on the shroud surface (Figure 8) which grinded off the bucket tip material.

Figure 8
Hard Ash Material Deposit on Stage 1 HPT Shrouds

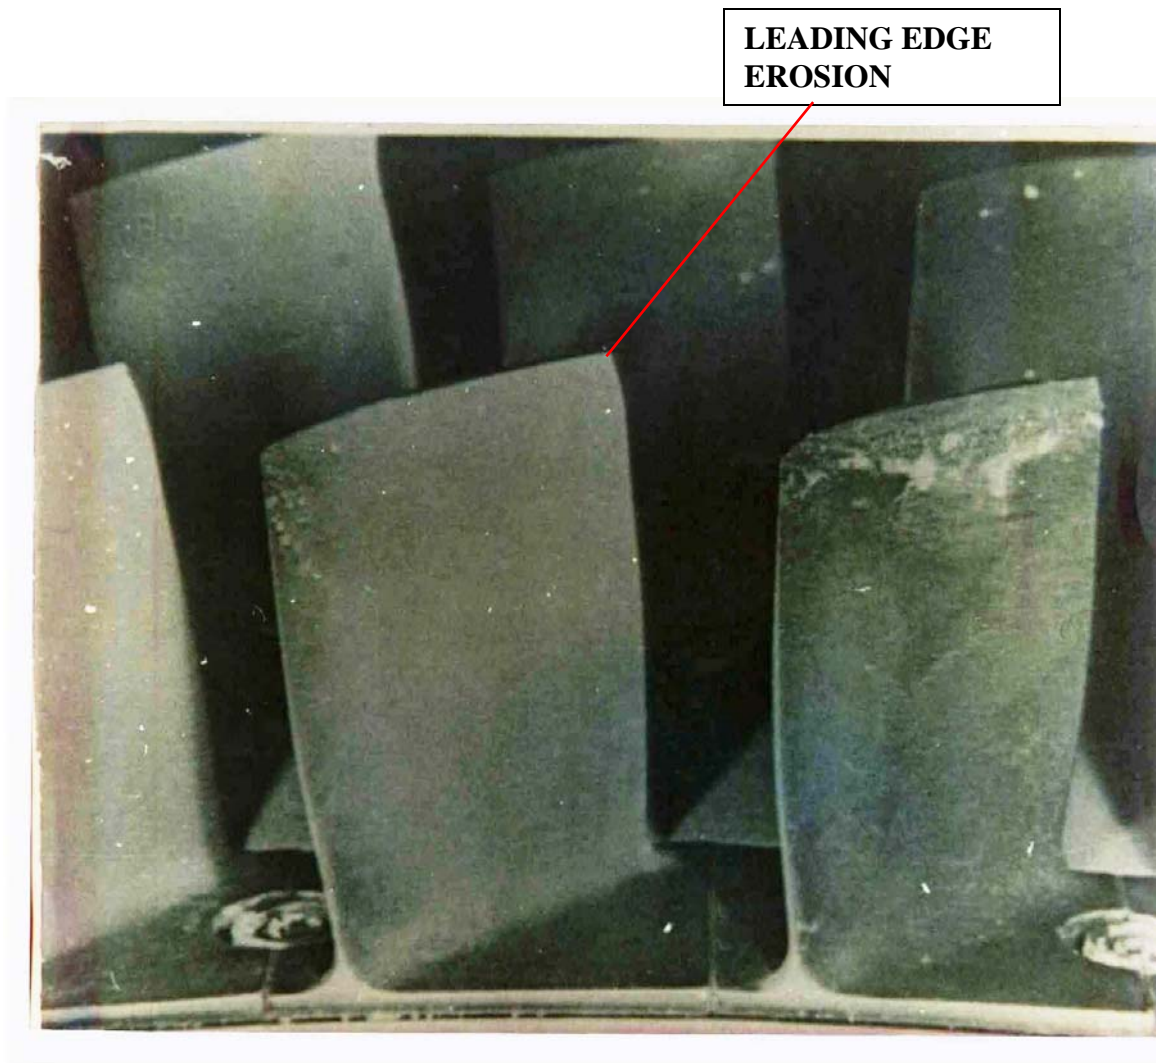
High Pressure Compressor (HPC) erosion (Figure 9) caused by ingestion of the ash particles resulted in minor stall margin decrease and compressor efficiency loss estimated to be 1%.

Figure 9
HPC Blades Leading Edge and Tip Erosion

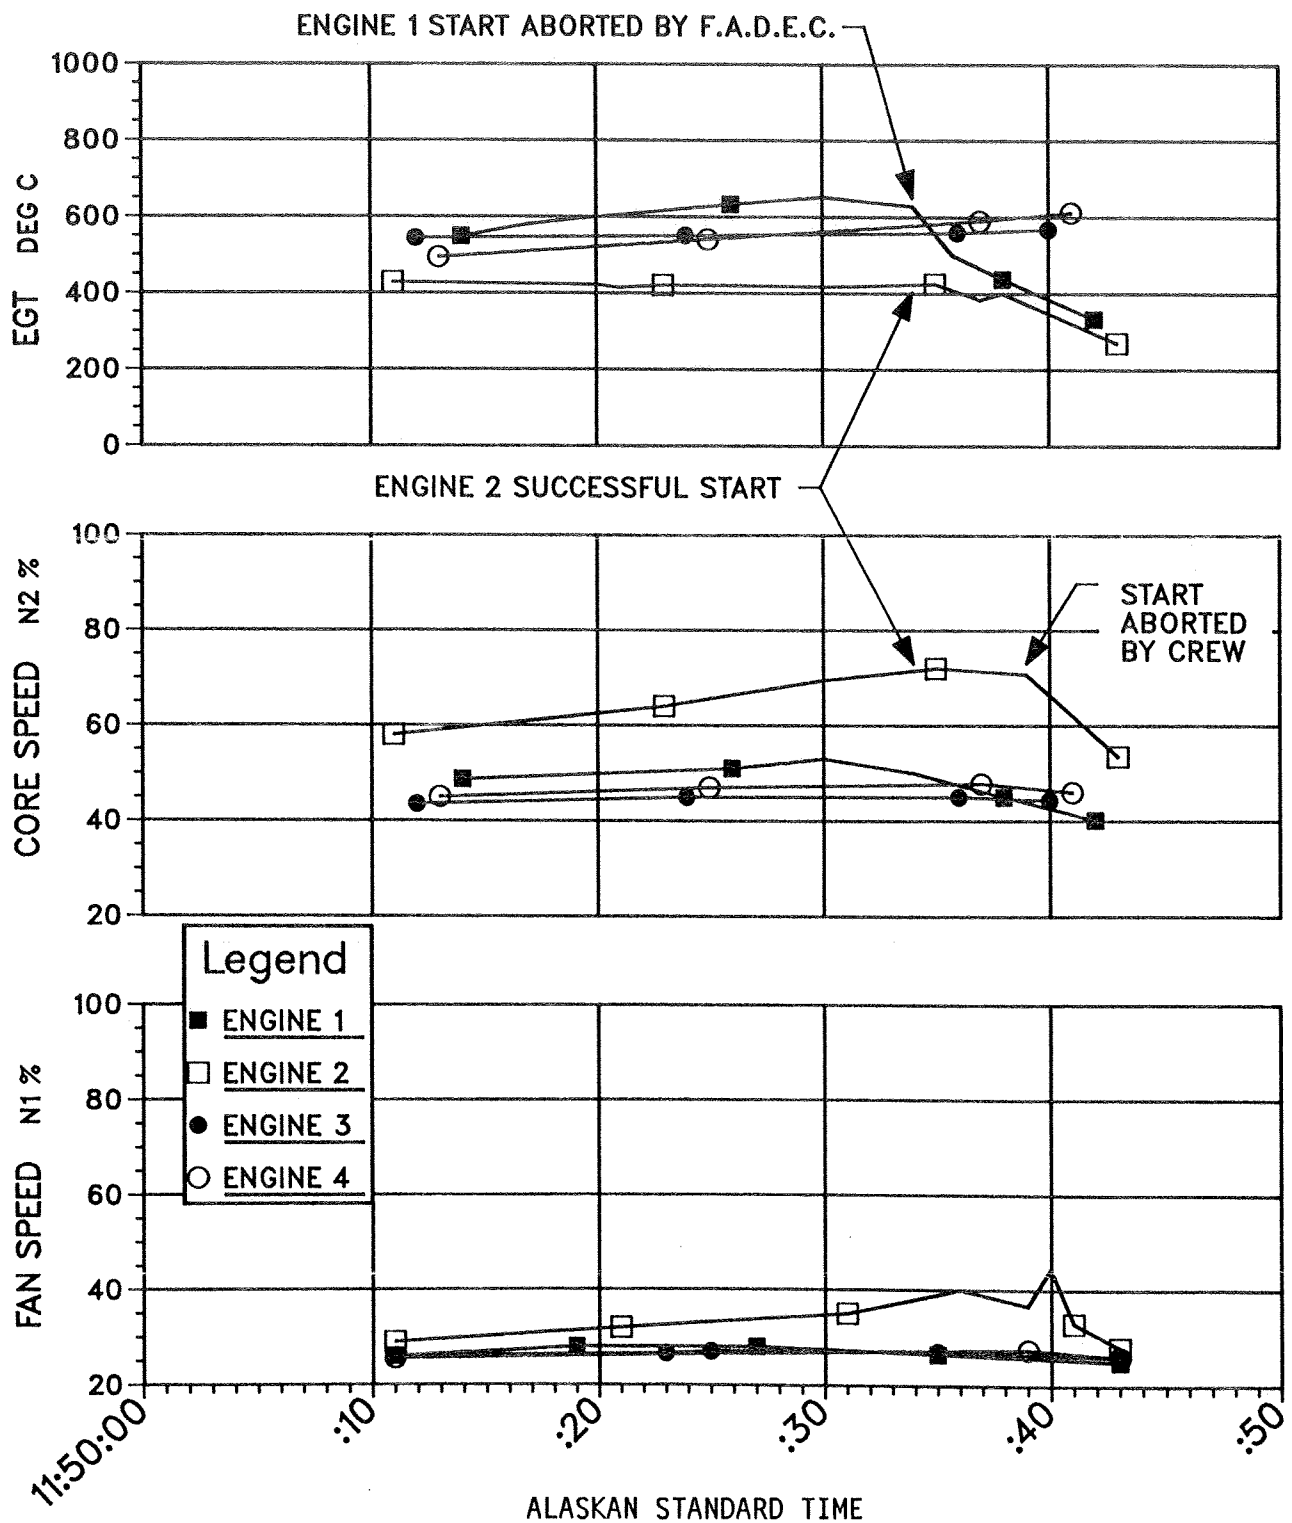
During the starts, autostart mode was used and at least one start appeared to have been correctly terminated by the FADEC start/stall logic. Most of the starts, however, were terminated by the crew overriding the autostart sequence and thus negating the adaptive automatic restart features of the control system while, in some of these cases, the engine or engines appeared to be on the way to a successful start (Figure 10).

Figure 10 Engine Parameters During First Recorded Start Attempt

Restarts should be initiated immediately. More than one attempt may be required to obtain a successful start. Autostart should be used (if available) since it simplifies starting the procedure and provides engine overtemperature protection. Compressor bleed should be turned on during restarts and during subsequent engine operation to maximize stall margin. Following restart, the engine performance/stall margin/EGT may improve with time, but it will not reach the pre-ash encounter level. Rapid throttle movement and maximum power operation should be avoided, if possible, since stall margin is decreased and some cooling circuit plugging may be present.
